MSC-07007

APOLLO 16

30-DAY FAILURE AND ANOMALY LISTING REPORT

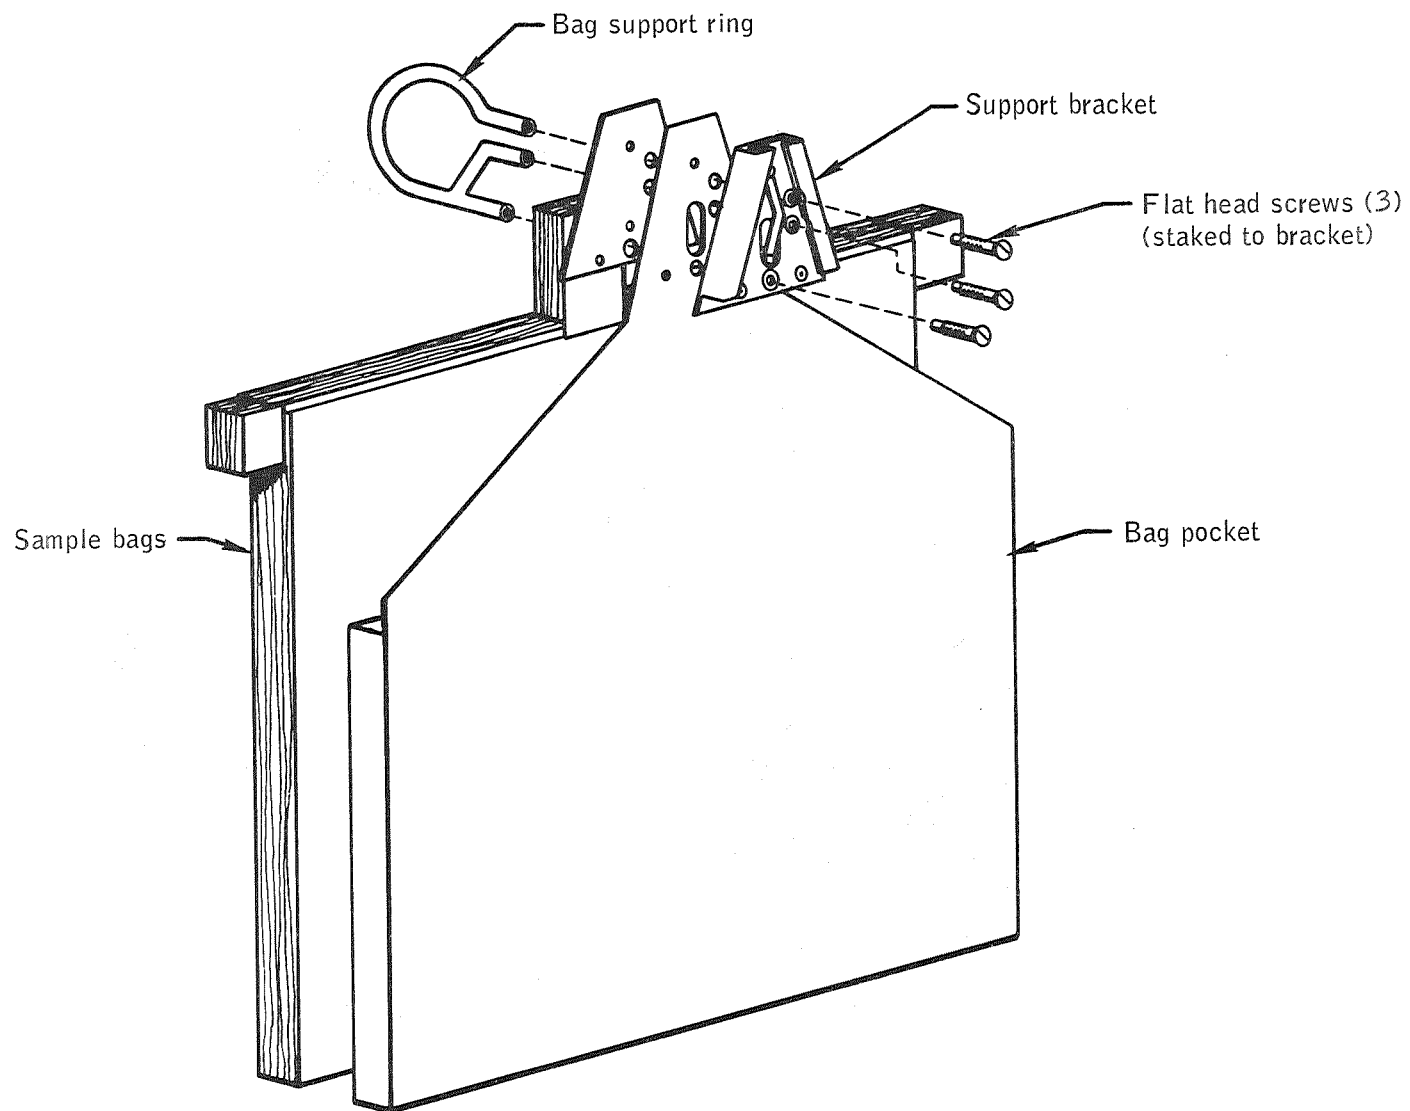
Figure 5-7.- Documented sample bag dispenser assembly.

The dispenser assembly is held together by three flat-head screws (fig. 5-7) which are retained by staking to the bracket. The use of loc-tite has not been permitted because of the possibility of sample contamination.

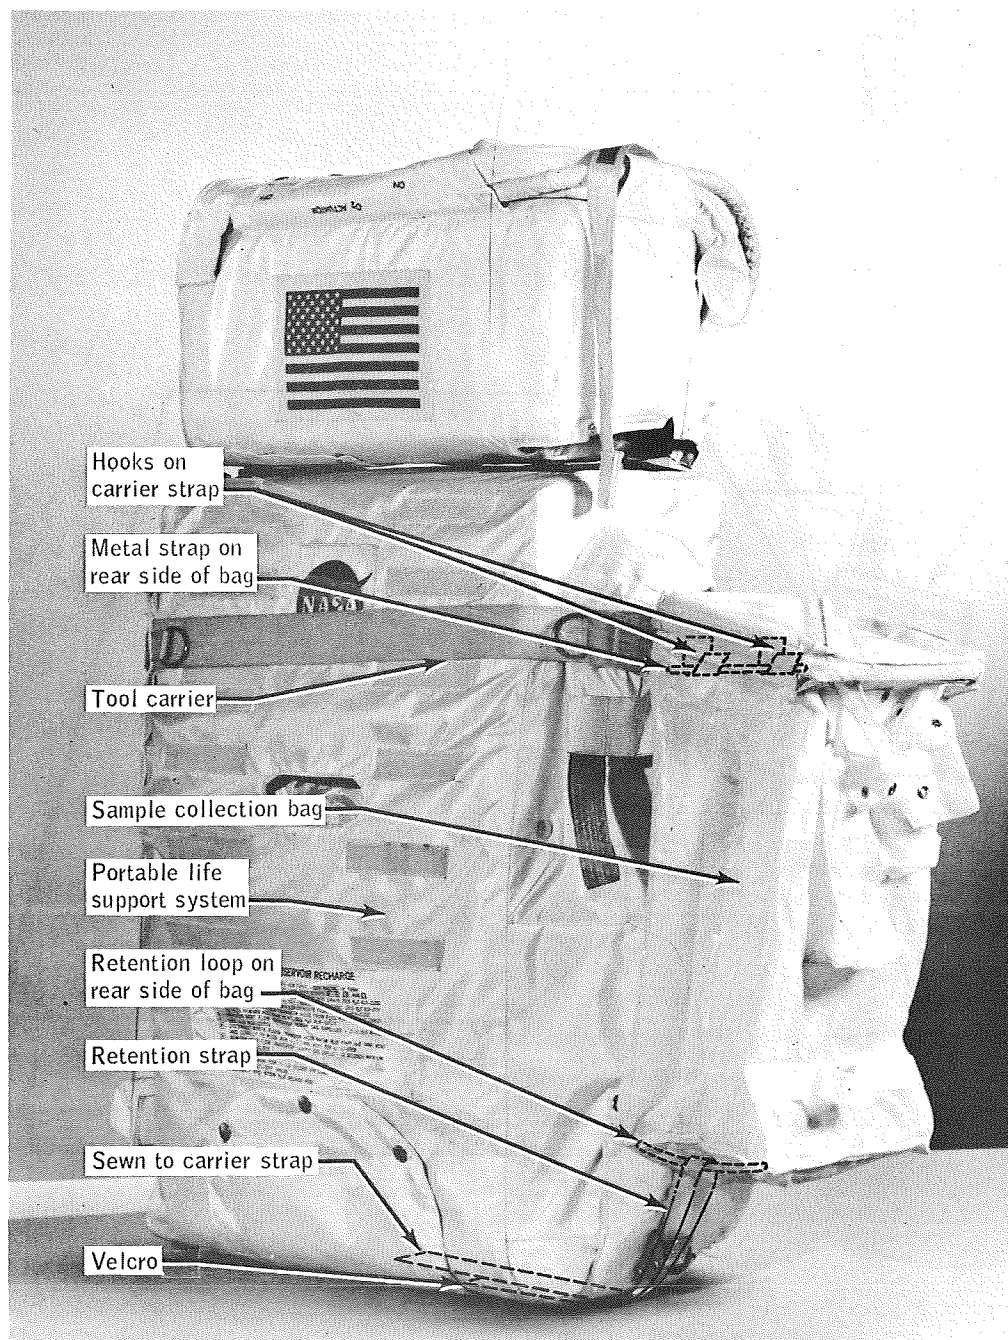
Figure 5-8.- Sample collection bag on portable life support system tool carrier.

The sample collection bag essentially consists of a Teflon bag on a metal frame (fig. 5-8). The bag opening is covered by a Teflon lid on a hinged metal frame. Attached to the metal frame on one side of the bag, about 2 inches below the lid, is a 3/8-inch-wide stainless steel strap with offsets to accommodate the two hooks on the tool carrier. About 1 inch from the bottom of the same side is a 1-inch-wide Teflon band, sewn to the bag, with an offset loop approximately 1 inch by 5 inches to accommodate the Velcro strap from the bottom of the tool carrier. The Velcro strap, when tightened down, keeps the bag from floating or bouncing off the hooks. During the lunar roving vehicle operations, the Velcro strap sometimes loosened so that the bag could come off the hooks.

Changes under consideration include the possibility of adding a keeper to the hooks.

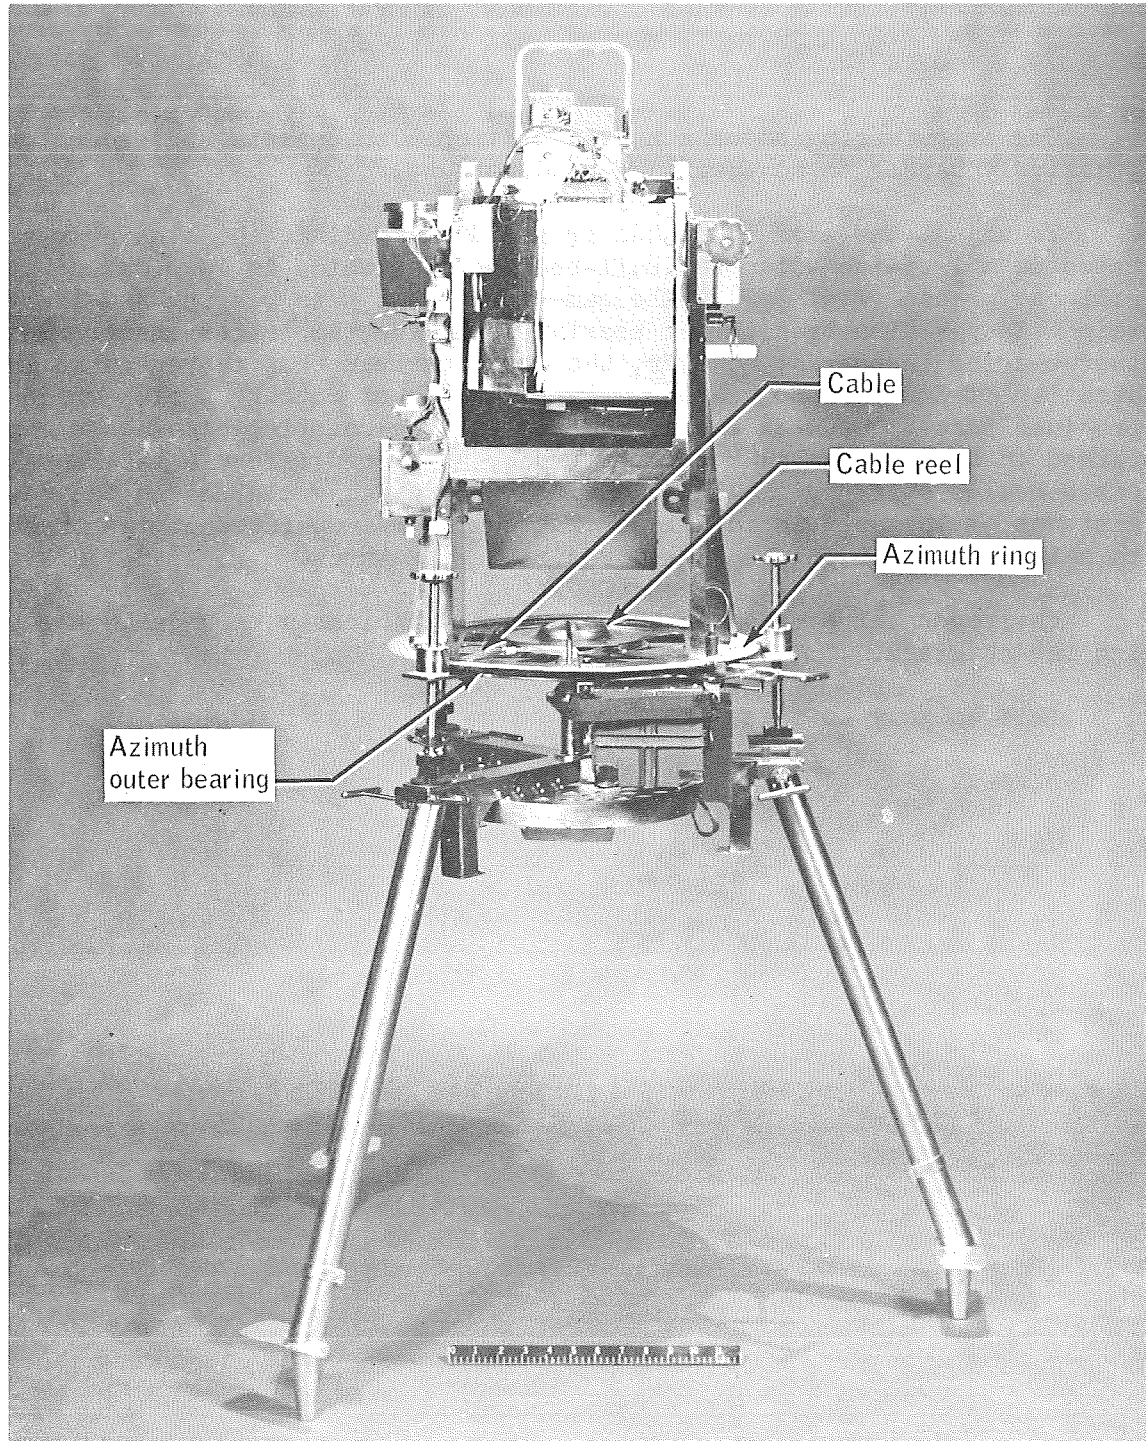
Figure 5-9.- Far ultraviolet camera.

Environmental effects on the bearings, lubricants, and cable are being investigated.

This anomaly is open.

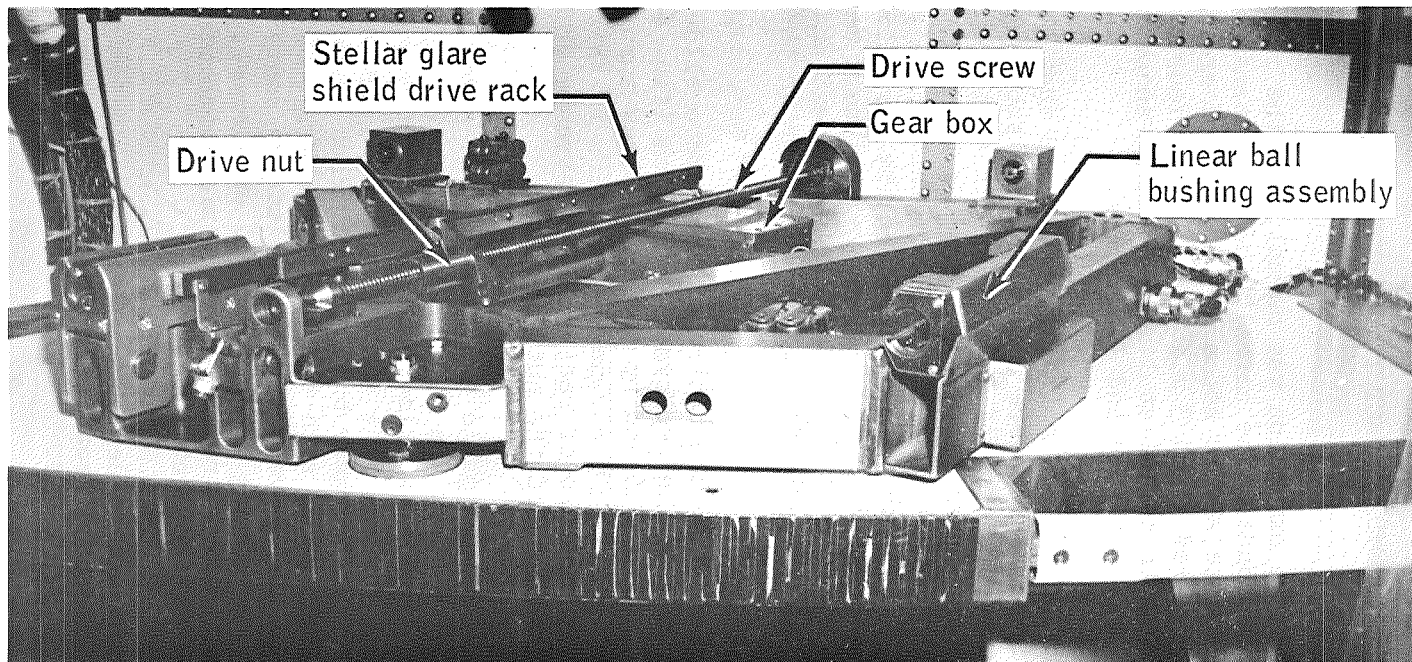
Figure 6-1.- Mapping camera deployment mechanism.

A re-evaluation of the entire deployment mechanism design is in progress. Tests to determine the effect of lubricant contamination of clutch friction surfaces will be performed.

This anomaly is open.

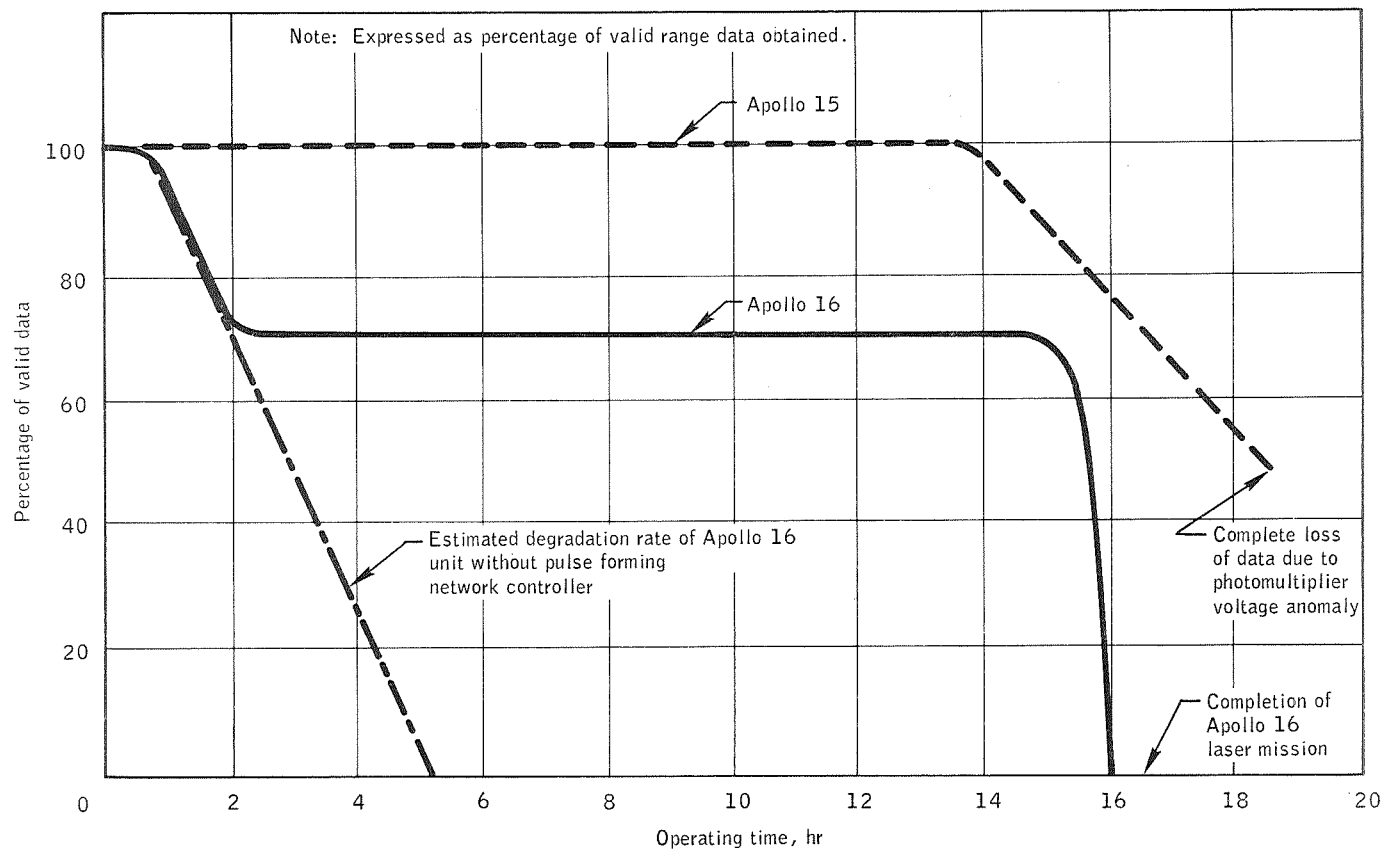
Figure 6-3.- Laser degradation versus operating time.

The laser altimeter performed normally during its first operating period - 41 minutes during lunar revolutions 3 and 4. Evidence of laser degradation began to appear early in the second operating period (revolution 16). The pulse forming network voltage controller began stepping to voltage position 1 (step 0 is the initial setting), and the laser output power,

when in step 0, was occasionally too low for ranging - as manifested by altitude readings of zero meters and an overflowing range counter. For this period, altitude data validity was about 68 percent; i.e., approximately 32 percent of the data was "zero".

Compensation was sufficient until the last 40 minutes of the final scheduled operating period. After this time, laser output was apparently too low for ranging against the sunlit lunar surface. One consequence of the pulse forming network controller operation was some loss of altitude data on alternate laser firings; therefore, data validity was only about 70 percent during most of this mission. Had the controller not been added to this unit, the amount of valid data obtained would have been significantly less. An estimate of the data that would have been obtained is shown in figure 6-3. The controller operates to increase input power to the laser if the laser output on the preceding operation was low, and to decrease input if the output was high. It appears that the threshold may have been low, or the voltage steps too large, so that inadequate output was obtained on the lower step, resulting in loss of altitude data. This was particularly true on illuminated portions of the lunar surface where background radiance decreases receiver sensitivity.

The laser module was processed in the same way, with the new type of bearing and other refinements, as the module in the delta qualification test. This test was conducted in a vacuum for 220 hours with operation on a simulated mission timeline for 50.5 hours. Total operations exceeded 9000 firings and the voltage controller had reached step 4 at the end of the test. Similar performance was expected of the Apollo 16 laser. The

number of prelaunch operations of the Apollo 16 laser was purposely restricted to conserve life; therefore, the rapid degradation could not be discerned preflight.

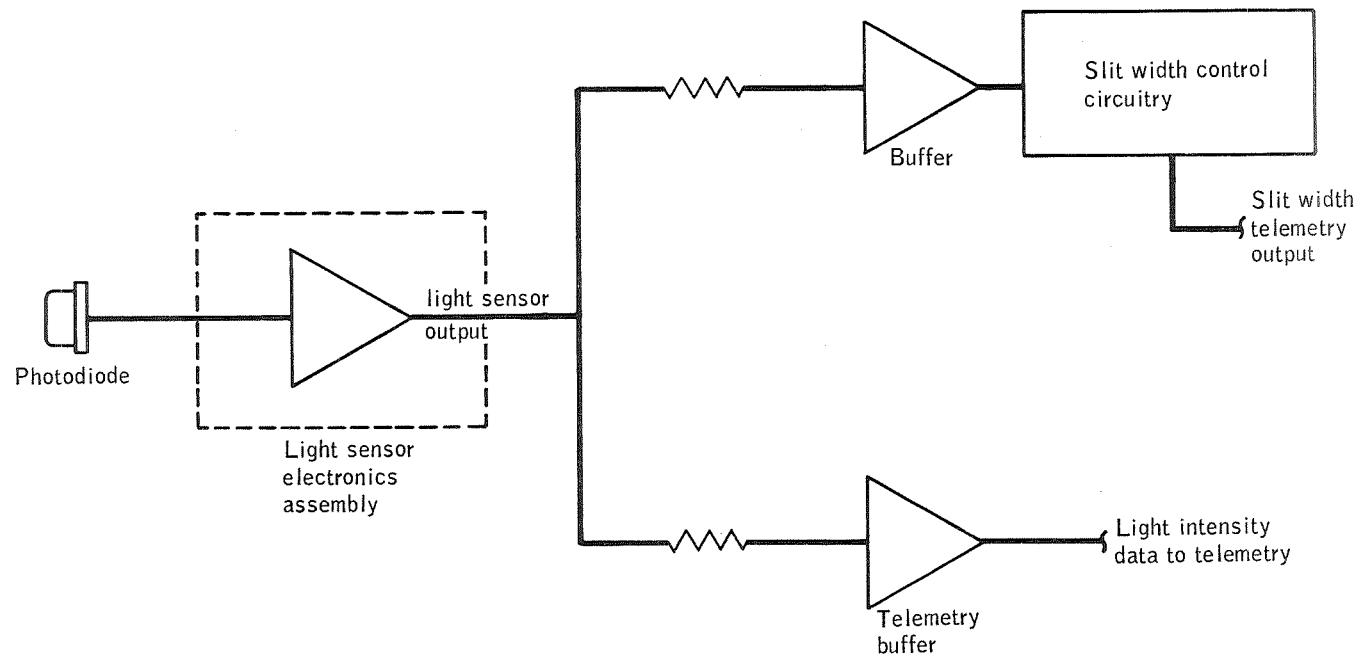
Figure 6-4.- Block diagram of panoramic camera automatic exposure control

The panoramic camera contains a light sensor and associated circuitry that determines the film exposure. As the scene luminance decreases, the output from the sensor decreases; the resulting signal delivered to the slit width servo causes the exposure slit to widen, thereby automatically increasing the film exposure. The slit width and the light sensor output are both telemetered (fig. 6-4).

Throughout the mission, telemetry indicated that the sensor output was too low, resulting in a slit width that was too wide. Consequently, an overexposure of the film occurred. Based upon preflight brightness calculations and real-time mapping camera exposure data, the degree of overexposure was estimated to be approximately 1 1/2 f-stops. As a consequence, the film processing was modified to compensate for this degree of overexposure. A preliminary review of the processed film indicates that the photography was not compromised.
